Minerals Inspection Report

Mine Name: Fox Canyon (5 acres)	Permit Number:	S/49/0080	Mine Status:	Active
Operator Name: Beck Construction	Inspection Date:	03/06/2014	Permit Fees:	Paid
Inspector(s): A. Abate	Inspection Time:	12:45	Bond Amount:	\$8,000
Attendee(s): Dana Beck	Weather:	cloudy	Bond Escalation:	
Inspection Purpose: Determine extent of reclamation work		Prior Inspection:not previously in		
Conclusions and Recommendations Mr. Beck will complete reclamation over the next few come back out to the site once the reclamation work the	weeks and apply for a partial		ne earthwork. We agree	d that I would

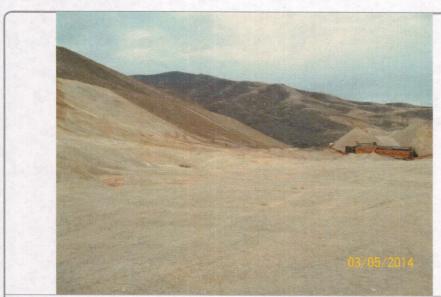
6.	Reclamation					
	The site consists of a flat pad and hillslope. Mr. Beck explained that the slope has been prepped for reclamation while the pad area will be the footprint for the condos.

The site is a barren hillslope that is a sand bar deposit near the Point of the Mountain area in Using the hilltop areas as a reference for surrounding native vegetation, the area consists of Utah County.

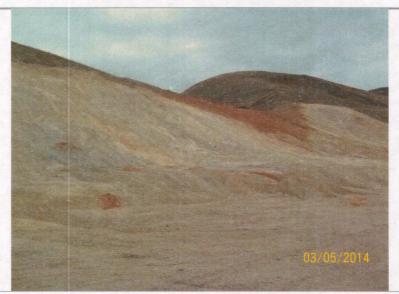
8.	Soils					
9.	Revegetation	\boxtimes				
	The upper portion of the slope was already topsoiled and seeded. Vegetation has started to come in but there is not much in the general vicinity of this canyon other than grasses.

grasses only.

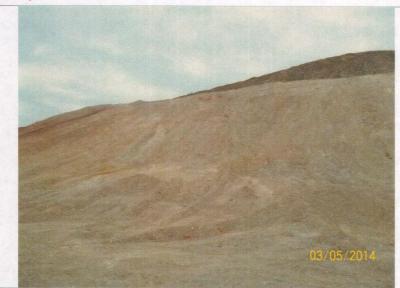
7.	Backfilling/Grading (trenches, pits, roads, highwalls, shafts)					
	The slope has been brought to an approximate 3:1 grade. Topsoil was salvaged and will be used to cover the slope prior to reseeding.

The slopes are graded and have been prepped to receive salvaged topsoil for seeding.
